Manhole Inspection Summary

Manhole # S15I__017MH

Inspection ☐ Is Incomplete Rating: **3) Fair**

Location Address: **GWYNNS FALL TRAIL**

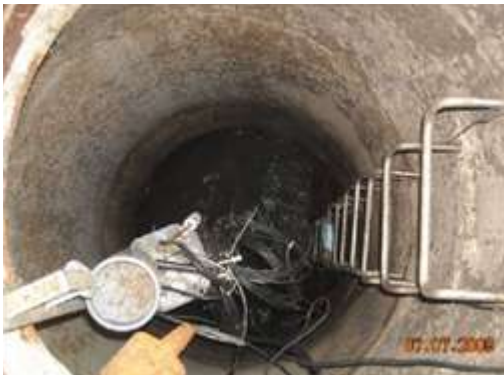
Miscellaneous

FLOW MONITOR INPLACE

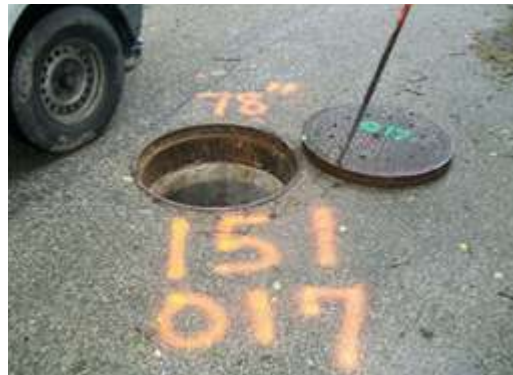
Miscellaneous

PAVEMENT MARKINGS

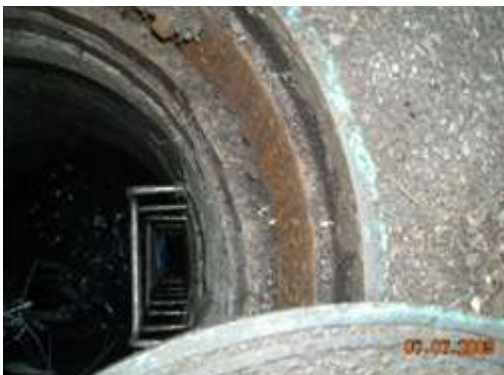
Defect 1

Frame Offset: **1.5** (in.) Condition: ☒ Sound ☐ Cracked ☐ Leaks

FRAME OFFSET

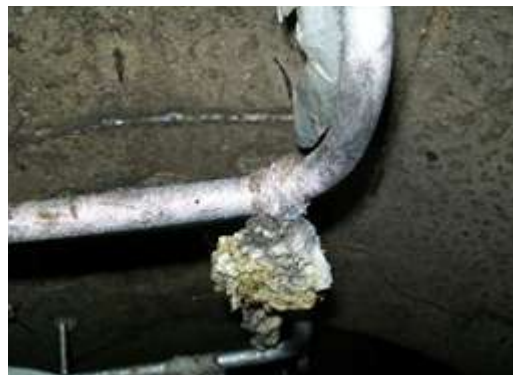
Defect 2

Surcharge ☒ **Evidence Of Surcharge** Depth: **5** (ft.) ☐ Active Surcharge Present

Evidence of surcharge

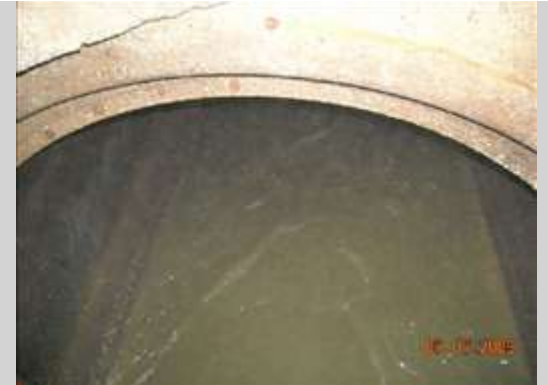
12 O'Clock Outflow

72 in. Circular Gravity Sewer
Pipe Out @ 12 O'Clock

Pipe Height: **76.8** (in.) Rod and Bar (Angled)
Pipe Material: **Unknown** ☐ Pipe Lined
Invert Depth: **16.55** (ft.) Flow Characteristics: **Slow**
Deposits: ☒ None ☐ Mud ☐ Sludge ☐ Debris ☐ Grease
Silt Depth: **0** (in.) Deposits Extent:
Infiltration: **None** Pipe Seal Cond: **Sound**

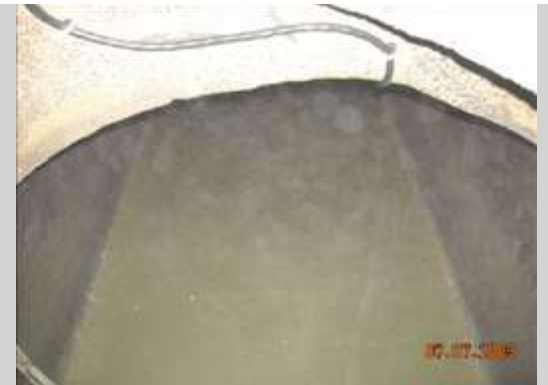
6 O'Clock Inflow

72 in. Circular Gravity Sewer
Pipe In @ 6 O'Clock

Pipe Height: **76.8** (in.) Rod and Bar (Angled)
Pipe Material: **Unknown** ☐ Pipe Lined
Invert Depth: **16.25** (ft.) Flow Characteristics: **Slow**
Deposits: ☒ None ☐ Mud ☐ Sludge ☐ Debris ☐ Grease
Silt Depth: **0** (in.) Deposits Extent:
Infiltration: **None** Pipe Seal Cond: **Sound**
